# Indoor Air Quality Assessment

| Site | Hollin Brook Primary School, Nottingham |

| Project | Hollin Brook Primary School, Nottingham: indoor air quality assessment (completed example) |

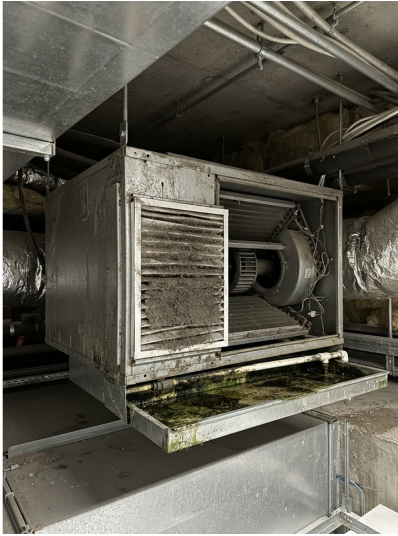
## Photos of the plant, intakes or grilles

| Condensate drain pans clean and draining | Action needed |
| What needs doing, or why not checked | ICT suite ceiling fan coil: slime and standing water in the condensate tray, filter heavily loaded. Fan coil off until cleaned. |

| Notes | Musty smell near the fan coil grille. Readings taken with the fan coil off and the door to the corridor open. |

### Recommendations 2: Clean the ICT suite fan coil condensate tray, clear the drain and change the filter.

| Recommendation | Clean the ICT suite fan coil condensate tray, clear the drain and change the filter. |

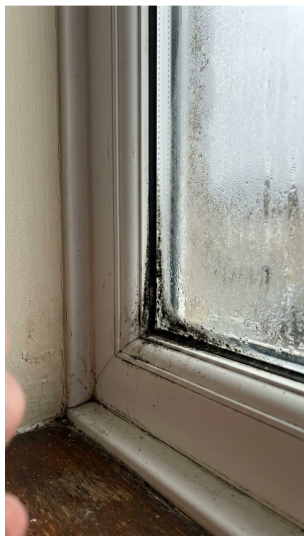
#### Photos

| Seen in this area | Condensation on windows, Visible mould |

| Source | Visible mould |

| Where | Class 6, window by the reading corner |

| What was found | Condensation on the inside of the glass and black mould spots along the bottom of the frame. |

| Could it explain complaints in that area? | Yes |

| Follow-up | Damp and mould inspection |

### Recommendations 3: Damp and mould inspection of the Class 6 window and reveal, and clean the mould.

| Recommendation | Damp and mould inspection of the Class 6 window and reveal, and clean the mould. |
