# Intercom and Door Entry Service Record

| Project | Victoria Court: annual door entry service (completed example) |
| Site | Victoria Court |
| Engineer | J. Moss, Kestrel Entry Ltd |

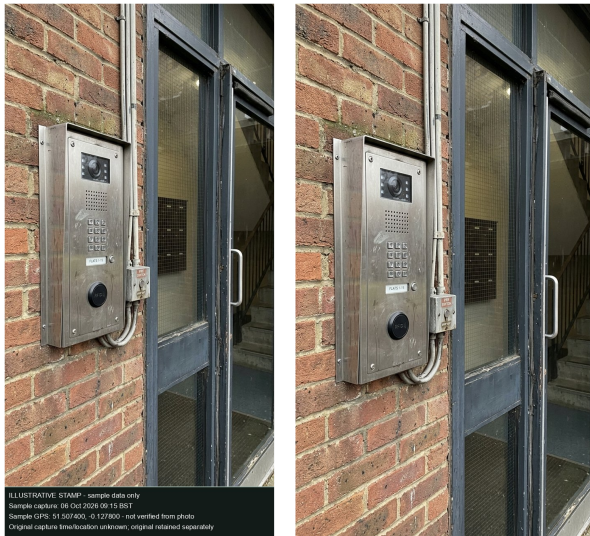
| Door closer and alignment | Defect |

Closer slamming; adjusted latch speed.

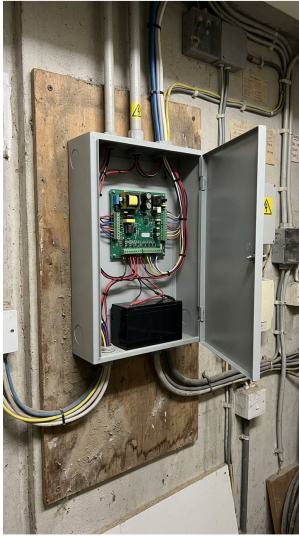
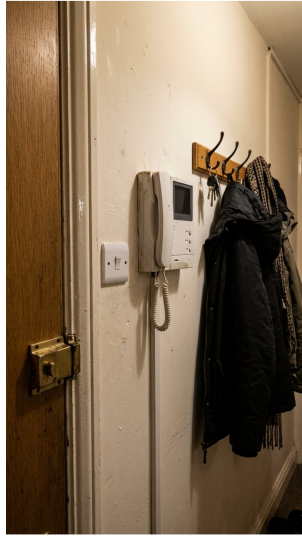
## Photos of the power supply, battery and handsets

| Power supply | OK |
| Battery backup tested | Defect |

| Faults and parts needed | Backup battery failed load test: replace. Flat 12 handset video faulty. Car park door fire release relay replaced on the day; responsible person told, as the release is essential fire-fighting equipment in this building. |

| Who will fix the faults, and by when | J. Moss to fit a new battery and the flat 12 handset by 20 Oct. |
