# Landlord Gas Safety Record

| Project | Flat 2, 15 Abbey Road: annual gas safety check (completed example) |
| Date of the check | 9 Oct 2026 |
| Engineer name | P. Grant |

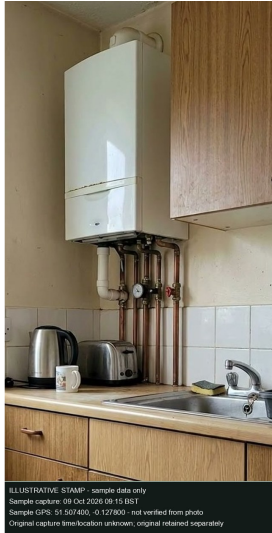
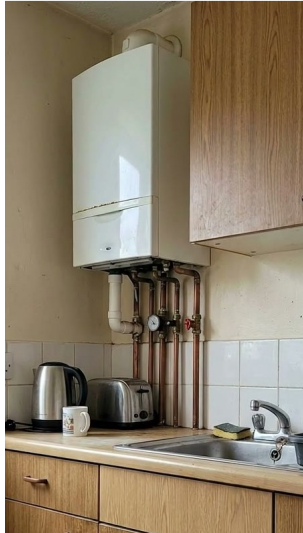
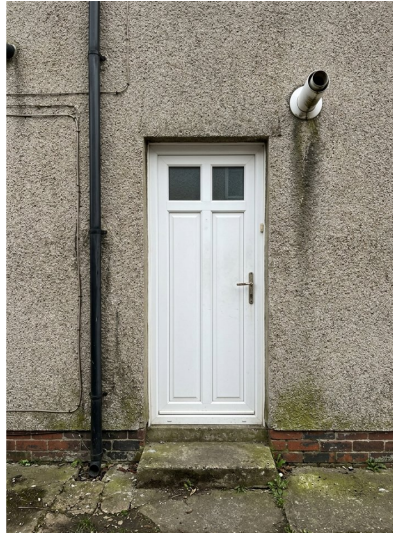
**Gas appliances in this room 1: Boiler**

| Type | Boiler |
| Make and model | Combi boiler 28 kW |
| Flue type | Room sealed |
| Flue performance test (spillage or flue flow) | Pass |
| CO reading (ppm) | 38 |
| CO/CO <sub>2</sub> ratio | 0.0011 |
| Ratio against the manufacturer's limit | Within the limit |
| Other analyser readings or notes | Flue gas temperature 62 °C. Readings taken at the flue test point. |
| Safe to use? | Yes |

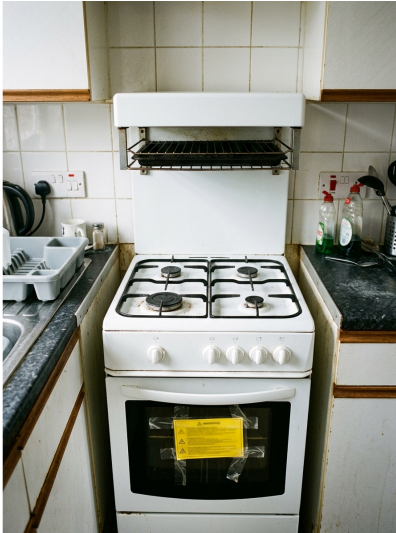
**Gas appliances in this room 2: Cooker or hob**

| Type | Cooker or hob |
| Make and model | Freestanding gas cooker |
| Safety devices operate correctly | Fail |
| Safe to use? | No |
| Unsafe situation | At risk |

| Safety defect identified | Flame supervision device on the oven not working. |

| Remedial action taken | Oven isolated with tenant's agreement; warning notice issued; landlord told. |

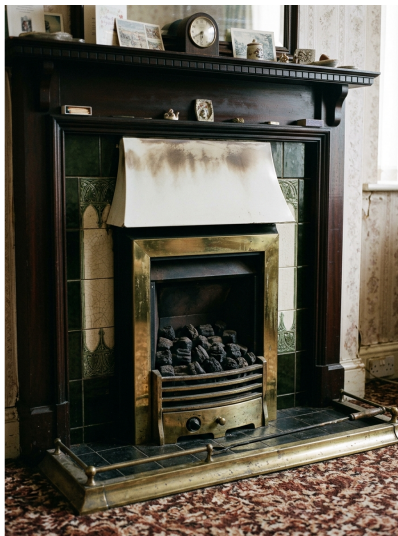
## Gas appliances in this room 1: Gas fire

| Type | Gas fire |
| Make and model | Coal-effect gas fire with brass surround |
| CO reading (ppm) | 96 |
| CO/CO <sub>2</sub> ratio | 0.0052 |
| Highest ratio allowed by the manufacturer's instructions | 0.0040 |

**Ratio against the manufacturer's limit** Above the limit

**Other analyser readings or notes** Canopy lightly sooted. Spillage test passed with the door and window closed.

**Safety defect identified** Combustion ratio 0.0052, above the 0.0040 in the manufacturer's instructions for this fire; canopy sooted.

**Remedial action taken** Fire turned off with the tenant's permission, at risk notice issued and the landlord told. Service and recheck booked for 16 October.
