# Legionella Risk Assessment

| Site | Bridgeview Offices, Preston |

| Project | Bridgeview Offices, Preston: legionella risk assessment (completed example) |

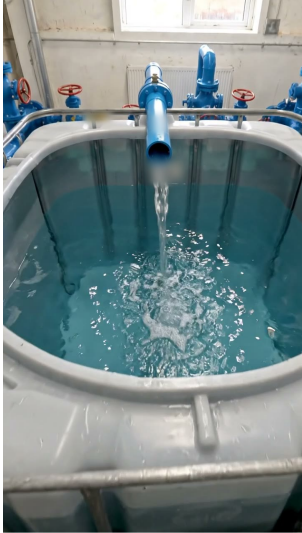
Photos of the tank, inside and out

Clean inside, with no sediment, scale or debris? No

Temperature of the stored cold water (°C) 19

| Issue | Sediment on the floor of the cold water storage tank |
| What needs doing? | Clean and disinfect the tank, then record it in the log book. |

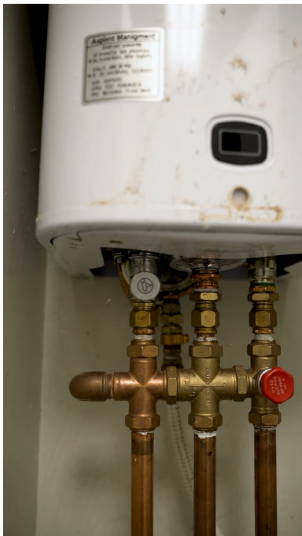
Photos

| Issue | Cleaner's cupboard heater: hot water reaches only 48 °C |

| What needs doing? | Check the heater thermostat and raise the setting so the outlet reaches at least 50 °C within a minute. Descale the tap. |
