# Lightning Protection Inspection

| Site | St Mary's Church |

| Project | St Mary's Church: annual lightning protection test (completed example) |

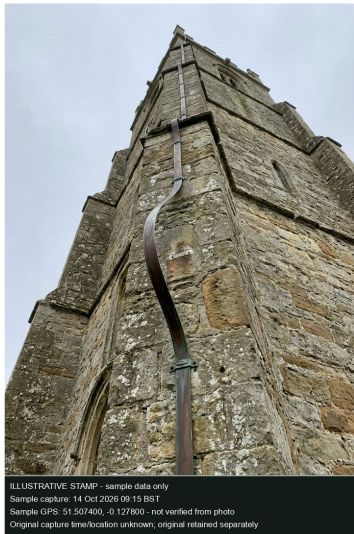
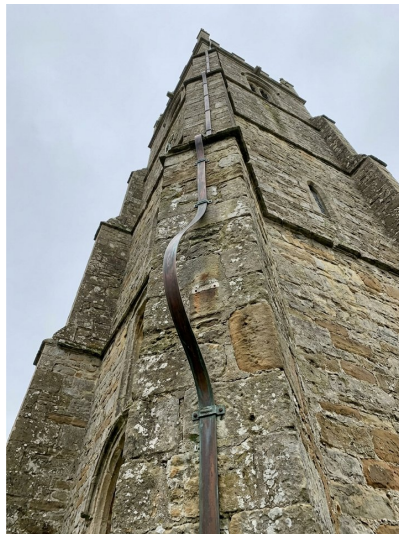
#### Photos

| Down conductors and fixings | Defect |

| What is wrong? | North tower down conductor detached from two fixings about 6 m up, tape bowing out from the wall. |

| Repairs needed | Refix the north tower down conductor. Clean the TP2 clamp and retest; if still above 10 ohms, add an earth rod at TP2. |

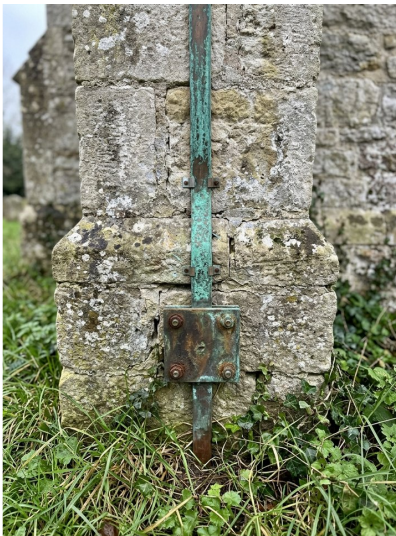
**Photo of the test point**

**Earth electrodes 2: TP2 south aisle**

| Resistance (ohms) | 14.5 |
| Previous reading (ohms) | 9.1 |
| Against the limit | Above the limit |
| Result | Fail |
| Notes | Reading up sharply on last year; clamp corroded. Clean and retest, then add a rod if still high. |
