## SITE SURVEY REPORT

# Loading and Unloading Check

| Project | Greenacre Builders Merchants, Taunton: steel delivery |

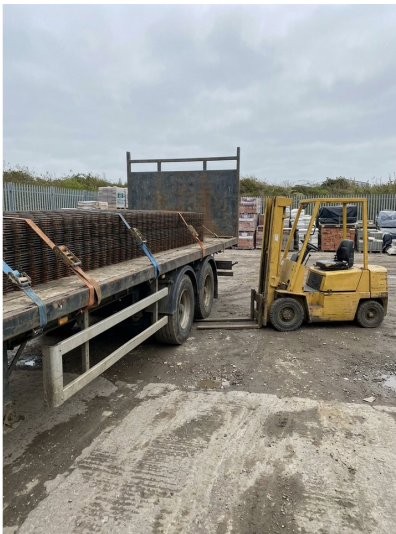
#### Load and area evidence

| Action, limitation or reason not applicable | One mesh pack had slipped against the headboard. Straps left on until the forklift was in position to take it. |

| Damage, instability or other concerns | Mesh pack slipped in transit but no damage. Noted on the delivery note. |
