# Pest Control Visit Report

| Date | 2 Oct 2026 |
| Site | The Old Forge Kitchen, Hereford |

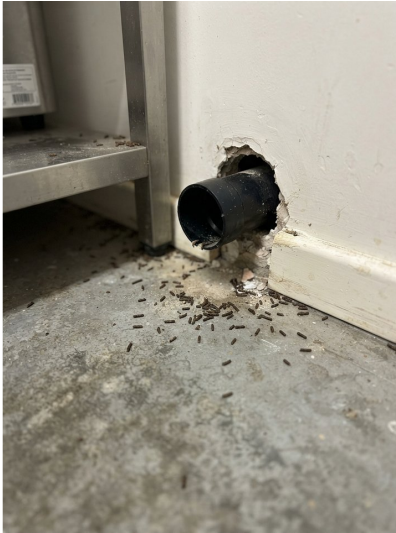
## Pest evidence and proofing photos

| Activity or evidence observed | About 15 fresh mouse droppings along the wall behind the shelving. One flour sack gnawed at the corner. |

| Activity or evidence observed | No droppings. Gap around the waste pipe through the wall about 25 mm. |

| Proofing, waste, hygiene and stock-storage findings | Gap around the pot wash waste pipe at MP-4 is the likely entry. Dry store door has a 10 mm gap under it with no brush strip. Flour sacks stored on the floor at the back of the dry store. |

| Action at this point | Two extra enclosed snap traps set. Gnawed flour sack bagged and handed to the chef for disposal. |

| Action at this point | Gap packed with wire wool as a temporary measure. |

| Further work and next visit arrangements | Return visit on 2026-10-06 to check traps. Permanent proofing of pipe gap to be quoted. |
