# Site Traffic Management Plan

| Site | Mill Meadow, Melksham |

| Project | Mill Meadow, Melksham: phase 2 site traffic management plan (completed example) |

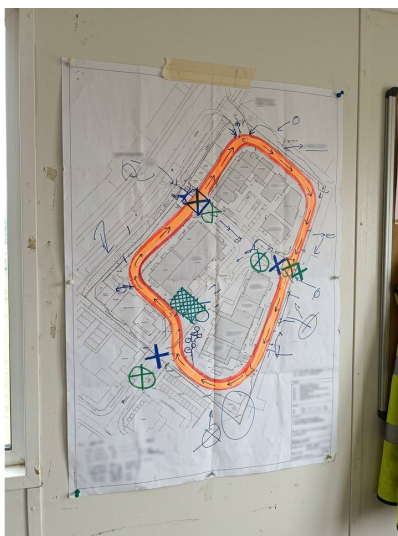
### Annotated route plan photos

| Site plan reference and revision | MM-TMP-02 rev C |

Haul road is compacted stone, soft at the edges after rain. Entry gate 2 is 4.2 m wide. No height restrictions on the route.

Fenced footpath from the welfare cabins to the plots along the north boundary. Heras fencing separates the footpath from the haul road. One marked crossing point at plot 14, controlled by a banksman during deliveries.

One-way loop around the laydown area so most vehicles drive through. Reversing only into the laydown bay with a trained banksman.

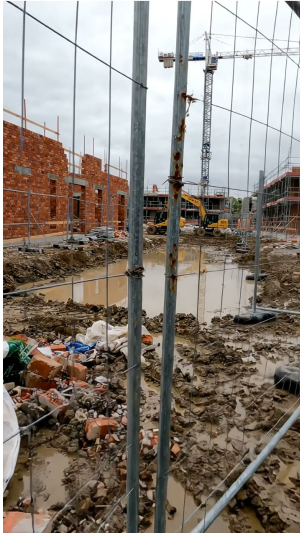
## Supporting photos

Standing water and soft ground on the haul road edge by plots 16 to 18 after heavy rain. Delivery vehicles kept to the stone centre until topped up.

Crossing point sign at plot 14 has blown down. Replaced the same morning.

### Further action 1: Top up and grade the haul road edge by plots 16 to 18.

| Action and evidence reference | Replace the crossing sign at plot 14. |

| Completion evidence | New sign fixed to a weighted post, checked on the afternoon walk. |
