## SITE SURVEY REPORT

# Steelwork Inspection

| Site | Unit 12 Anker Park, Tamworth |

| Project | Unit 12 Anker Park, Tamworth: warehouse steel frame (completed example) |

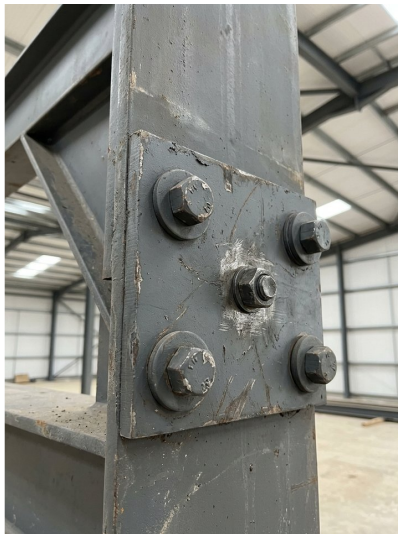
Supporting photos

Haunch connection H6/B, rafter to column

Bolt count, grade markings and snug tightness; paint damage around the joint

S-CD-300 detail 12, 8 no. M24 bolts

8 bolts fitted. One bolt missing washer on the outer face. Paint scuffed 200 mm by 50 mm on the flange.

Deviation

| Non-conformance and engineer response references | H6/B missing washer and paint damage raised as NCR-12-031. Engineer's response awaited. |

| Action and evidence reference | Fit missing washer at H6/B and retighten to the tightening procedure |
| Completion evidence | Washer fitted 23 September, bolt tightening record BTR-12-06 updated. |

| Action and evidence reference | Touch up paint at H6/B to the coating specification |
