# TMV Service Record

| Project | Oak Lodge Care Home: annual TMV service (completed example) |
| Service date | 7 Oct 2026 |
| Engineer | G. Holt, Holt Water Services |

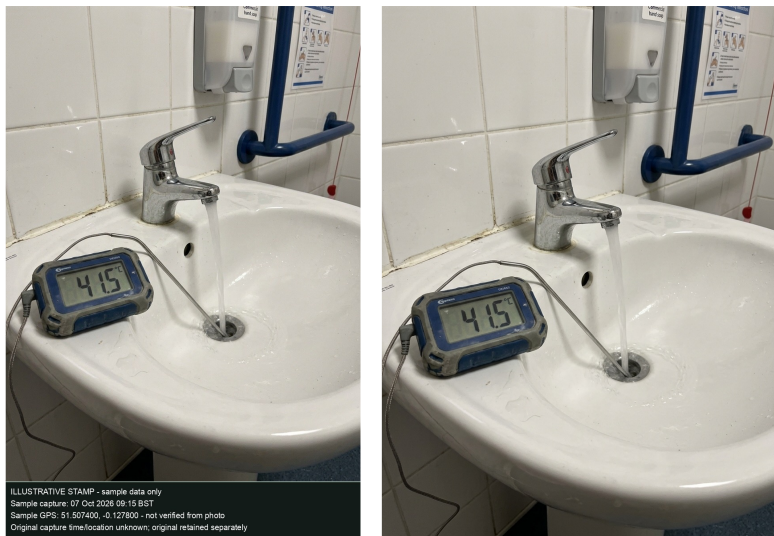
**Photos (valve, tag and thermometer reading)**

### Valves by room or ward 1: Room 3

| Outlet in this room | En-suite basin |
| Valve | TMV3 |
| Measured mixed temperature (°C) | 41.5 |

| Against the allowed difference | Within |

| Fail-safe test (cold supply isolated) | Pass |

| Result | Pass |

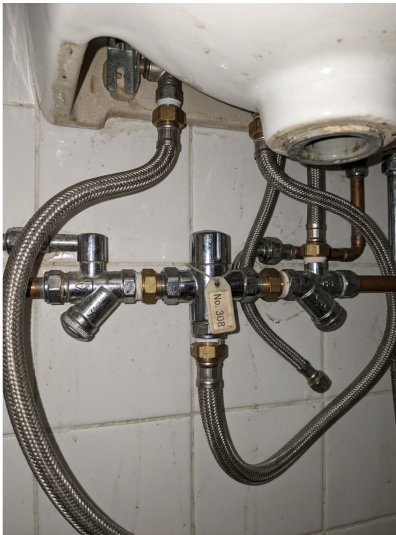
## Photos (valve, tag and thermometer reading)

| Room or ward | Room 12 |

| Outlet in this room | En-suite basin |

| Measured mixed temperature (°C) | 41.2 |
| Against the allowed difference | Within |
| Strainers and check valves cleaned? | No |

| This room: strainers not cleaned | 1 |

| What needs doing? | Fit an access hatch to the boxing under the room 12 basin so the strainers can be cleaned. |
