# Vehicle Inspection Checklist

| Project | Brightwell Heating fleet: daily van check (completed example) |
| Registration number | BW71 HTG |
| Make and model | Ford Transit Custom |

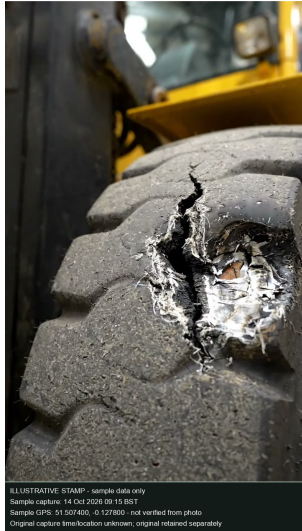
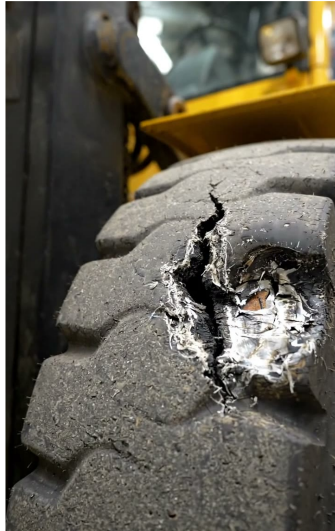
**Defects 1: Nearside front tyre: cut in the sidewall, cords not showing.**

| What is wrong? | Cut in the nearside front sidewall. |

What is the defect and where? Nearside front tyre: cut in the sidewall, cords not showing.

Can the vehicle be driven? Dangerous: do not drive

Result Dangerous defect: do not drive

Repair carried out and by whom Tyre replaced by Reading Tyre Centre, mobile fitter.
