# Welding Inspection

| Project | Longton Works, Stoke-on-Trent: mezzanine frame welding inspection |

| Job, assembly and drawing revision | Job TS-2291, mezzanine frame beam-to-column assemblies, drawing TS-2291-GA-03 rev C |

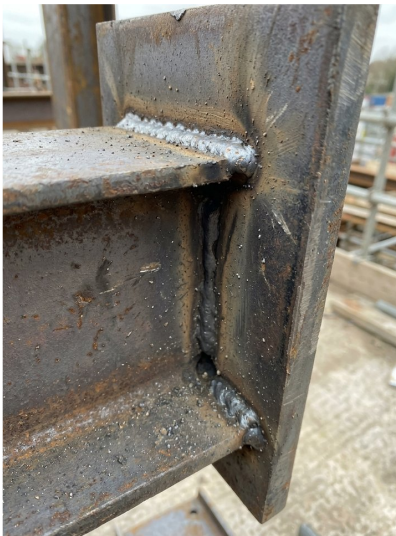
**Weld joint 2: J-04, beam B2 end plate fillet weld**

| Preparation, fit-up and pre-weld checks | Fit-up gap up to 2 mm on the top flange |
| In-process observations and specified parameter evidence | Run sheet RS-0917 shows travel speed higher than the other joints |
| Post-weld visual findings and dimensions | Undercut about 1 mm deep over 30 mm at the toe on the top flange. Leg 7 mm at the start against 8 mm required. |
| Result | Repair or review required |

| Approved repair instruction and affected weld IDs | Repair instruction RI-2291-01: grind out the undercut on J-04 and add a run to bring the leg to 8 mm. Welder W-07 to WPS-TS-014. |
| Reinspection and NDT report references | J-04 to be reinspected visually and by MT after repair, reports VI-2291-04R and MT-2291-04 |

| Completion evidence | Repair welded 21 September, reinspected visually and found to meet the recorded criteria, VI-2291-04R. |
