# Quarterly PPM Visit Report

| Site | Harbour House, Plant Room B1 |

| Report reference | PPM-2026-Q3-B1 (sample) |
| Visit type | Planned visit, quarterly round |

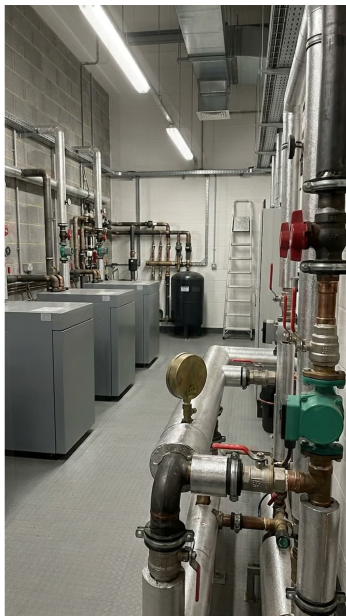
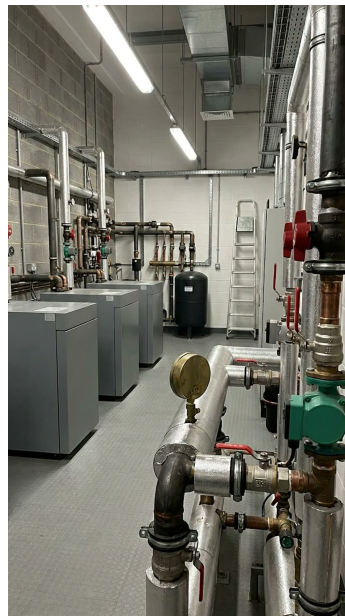
##### 1. Boiler condition

Boilers 1 to 4 running. No leaks on the flow and return, valves labelled. System pressure 1.4 bar, flow at 72 degrees. Isolation valve on boiler 3 stiff, needs exercising. Casings clean and undamaged, floor dry under the boiler row. Expansion vessel at the end of the row, no corrosion, no weeping at the connection.

| Boiler 3 (B1-BLR-03) | Pass with 1 minor defect. 8 of 8 tasks completed. Isolation valve stiff |

| Defect 1 | Boiler 3, return isolation valve stiff. Priority: minor. Action: exercise and lubricate, replace if it does not free. Owner: D. Walsh, Tideway. Target 9 Oct 2026. Open |

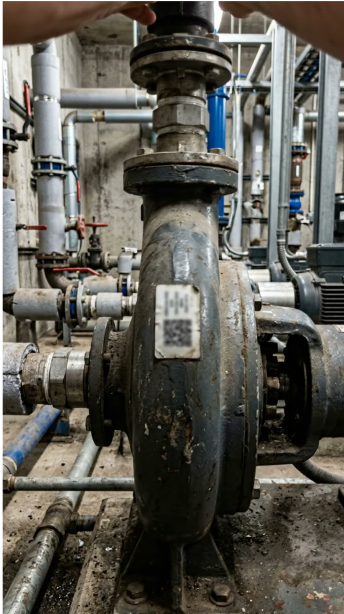
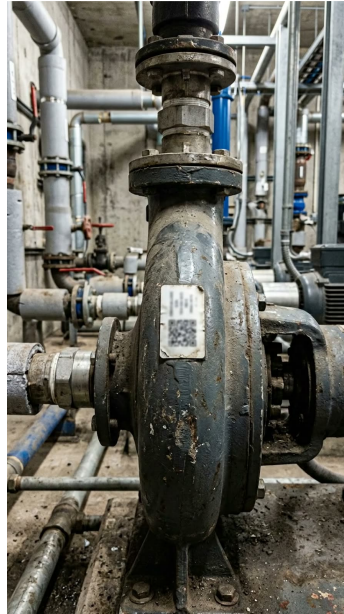
## 2. Pumps and valves

Pump 2 running quietly, no leaks on the seals. Isolation valve stiff, needs exercising. Asset label on the casing is in place and scans. Surface rust and flaking paint on the casing and flanges, no weeping at the joints. Holding down bolts tight. Plinth dusty, no oil or water on it.

| Pump 2 (B1-PMP-02) | Pass with 1 minor defect. 6 of 6 tasks completed. Isolation valve stiff |

| Defect 2 | Pump 2, suction isolation valve stiff. Priority: minor. Action: exercise and lubricate. Owner: D. Walsh, Tideway. Target 9 Oct 2026. Open |
| Observation | Pump 2 casing has surface rust and flaking paint. No leak. Clean and repaint at the next visit |

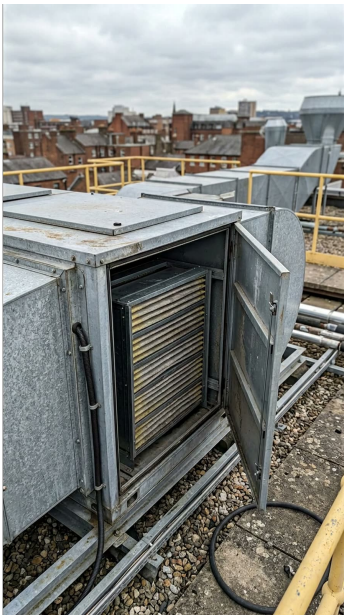
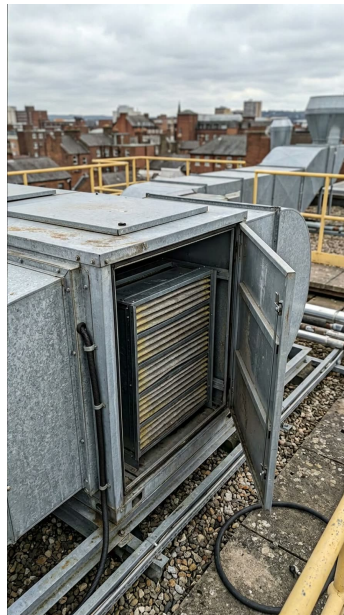
## 3. Air handling unit

Rooftop AHU 1. Filters dirty, replacing on this visit. Belt tension fine. Access door opens fully, hinges and catch sound. Light surface rust on the top panel, no holes. Roof edge protection in place around the unit.

| AHU 1 filter pressure drop, before | 240 Pa. Change point on the asset record 200 Pa |
| AHU 1 filter pressure drop, after new filters | 95 Pa |

| Air handling unit 1 (RF-AHU-01) | Pass after work. 7 of 7 tasks completed. Filters replaced |

| AHU 1 filters | 4 panel filters replaced like for like. Old filters bagged and removed from site |

| Defect 3 | AHU 1, filters dirty and above the change point. Priority: minor. Action: filters replaced on this visit. Owner: D. Walsh, Tideway. Closed 25 Sep 2026 |

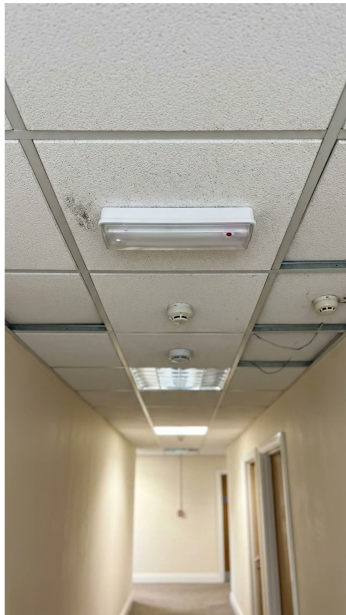
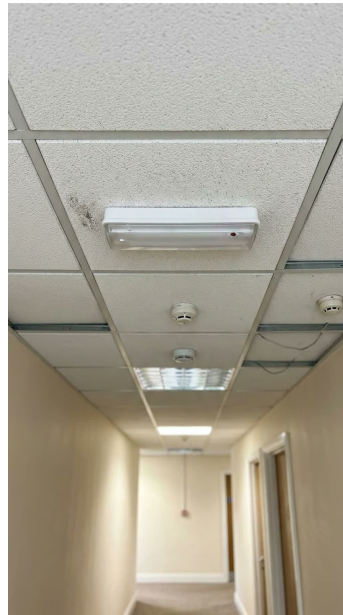
**4. Emergency lighting**

Corridor fitting 14, charge indicator lit, diffuser clean and secure. Dark staining on the ceiling tile beside the fitting. Fitting itself is dry. Reporting the tile to the building manager so the cause can be found.

| Emergency lighting, level 1 corridor (L1-EML-01 to 16) | Pass. 16 of 16 fittings lit on test. Ceiling tile beside fitting 14 stained |

| Defect 4 | Level 1 corridor, ceiling tile beside fitting 14 stained. Priority: minor. Action: find the cause and replace the tile. Owner: building manager. Reported 25 Sep 2026. Open |
